## EDIA-PRO: PRACTICAL TIPS

### 1. Injection signal form – electromagnetic injectors

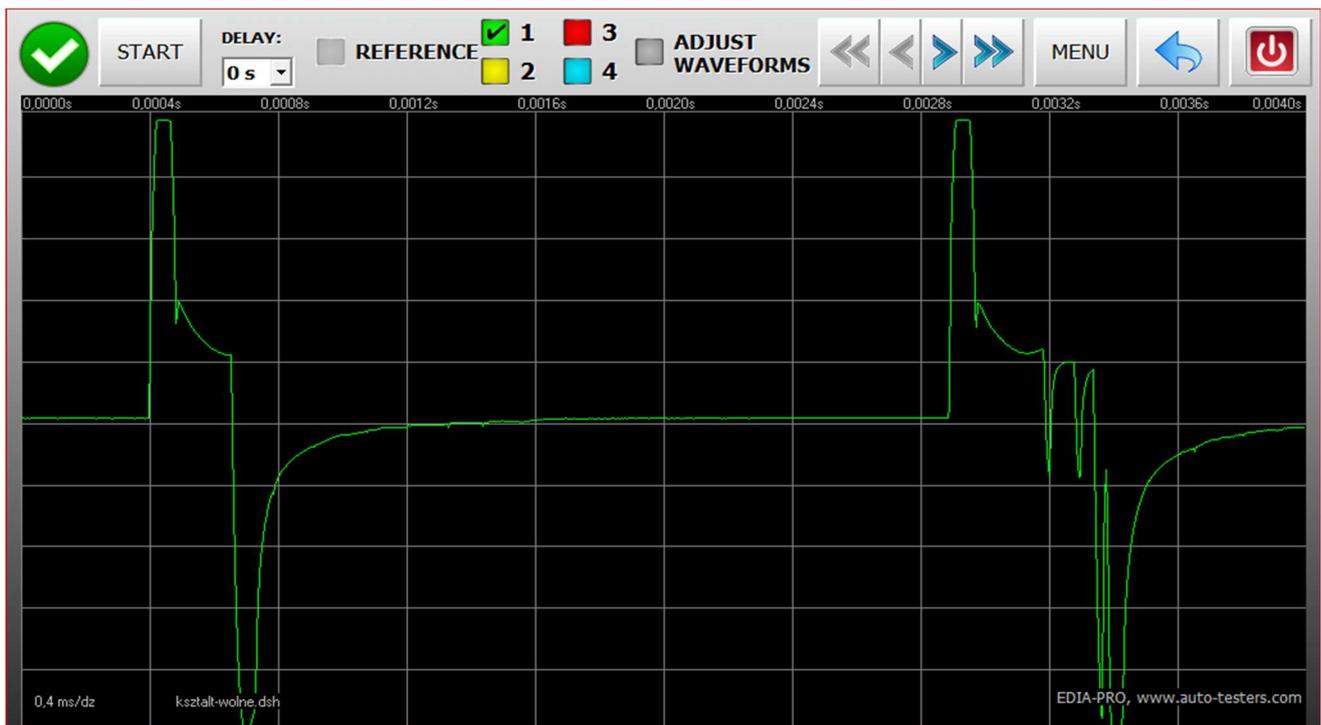
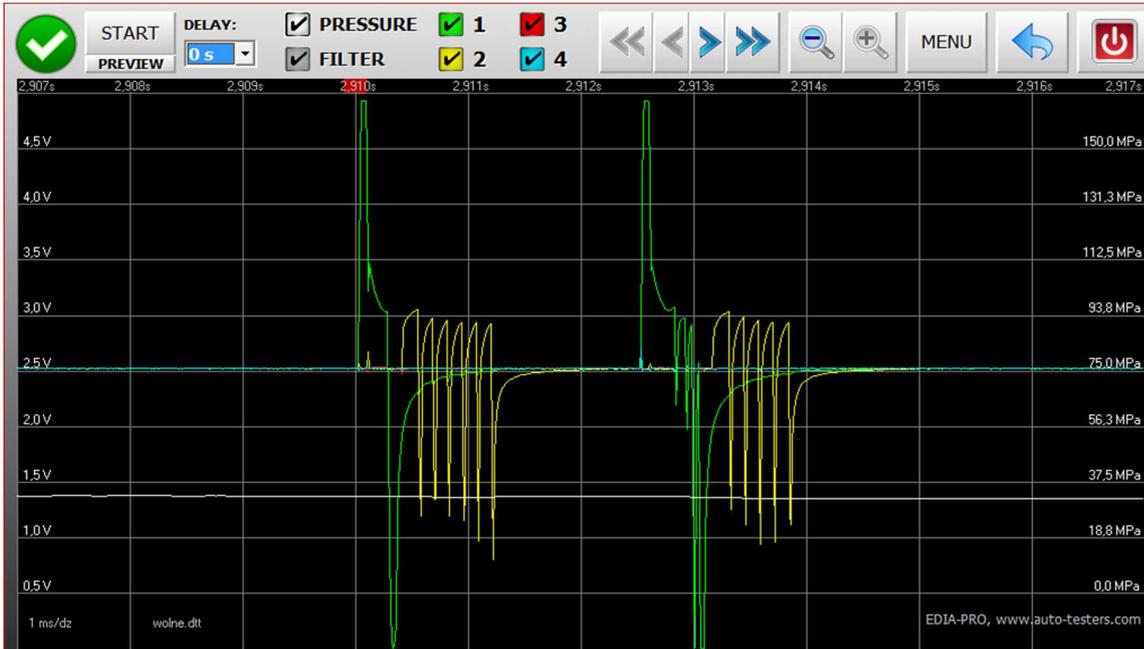
#### Example: FIAT JTD 1.9 (CRI 1 injectors, EDC15 driver)

This variant of the BOSCH system is characterized by a series of short pulses on one injector immediately after the injection signal on another injector. These serve to charge the internal capacitor in the controller. The controller uses the inductance of the injector to obtain a higher voltage, which will then be used at the start of the next injection. These pulses are too short to open the injector.

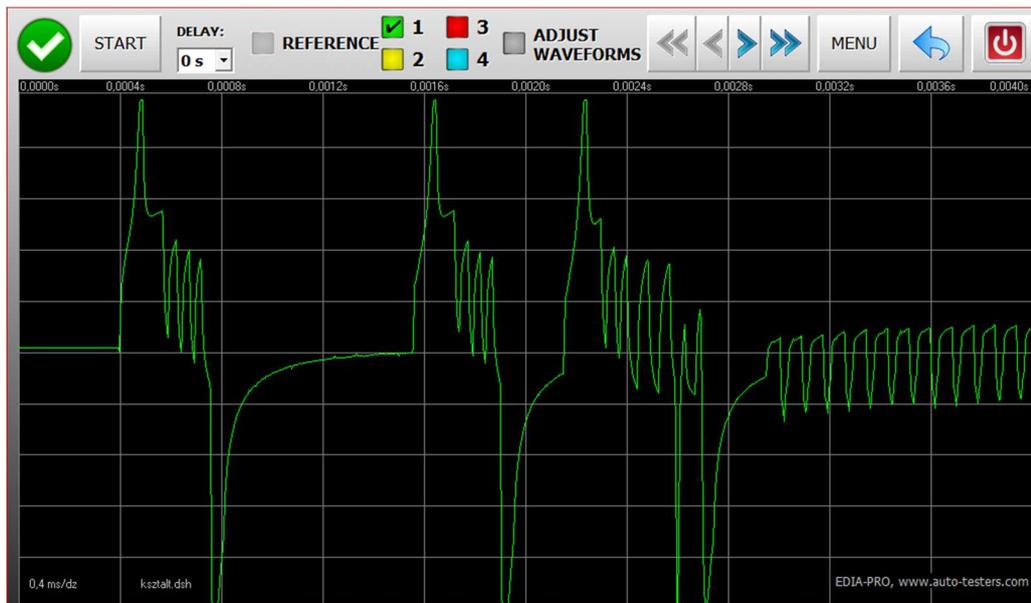
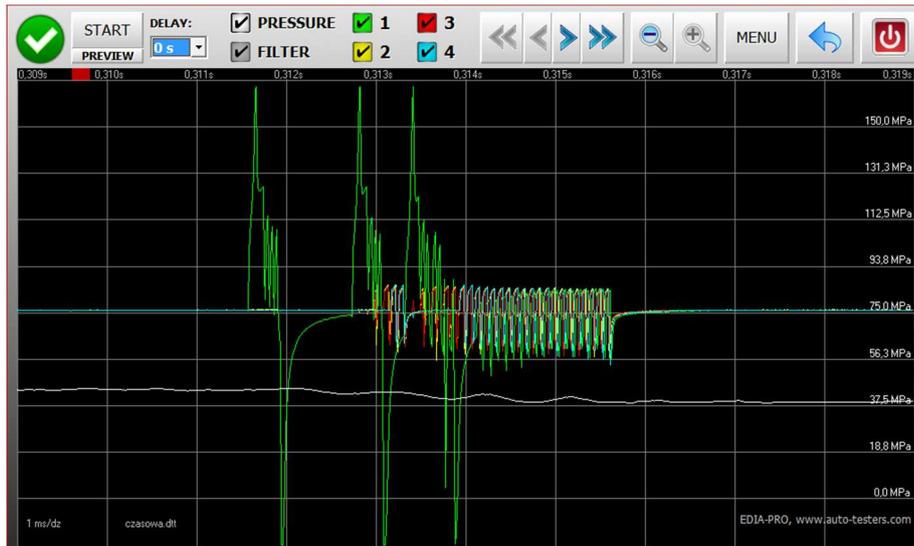
#### Example: Fiat Linea 1.3JTD (injectors CRI 2.2, IAW 6F3 driver)

The timing analysis waveform shows a series of capacitor charging pulses in the controller – pulses are generated immediately after the injection in all injector circuits.

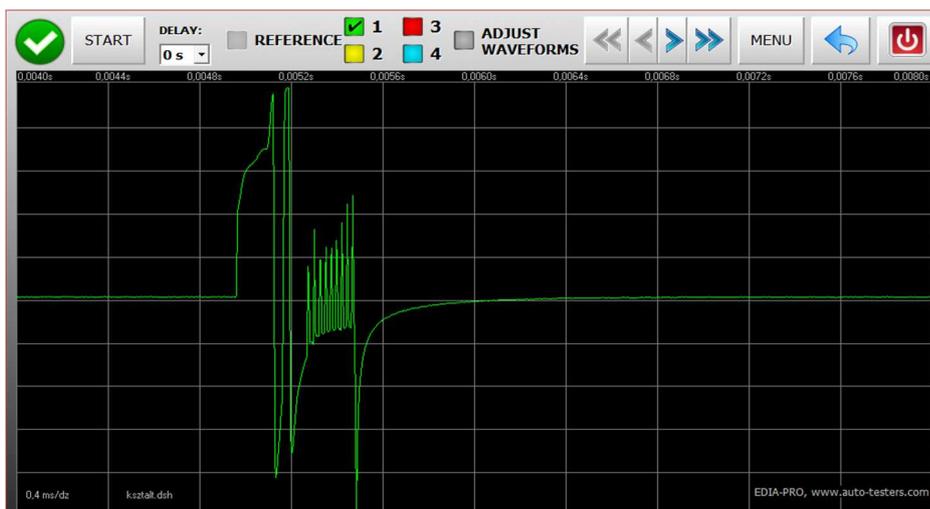
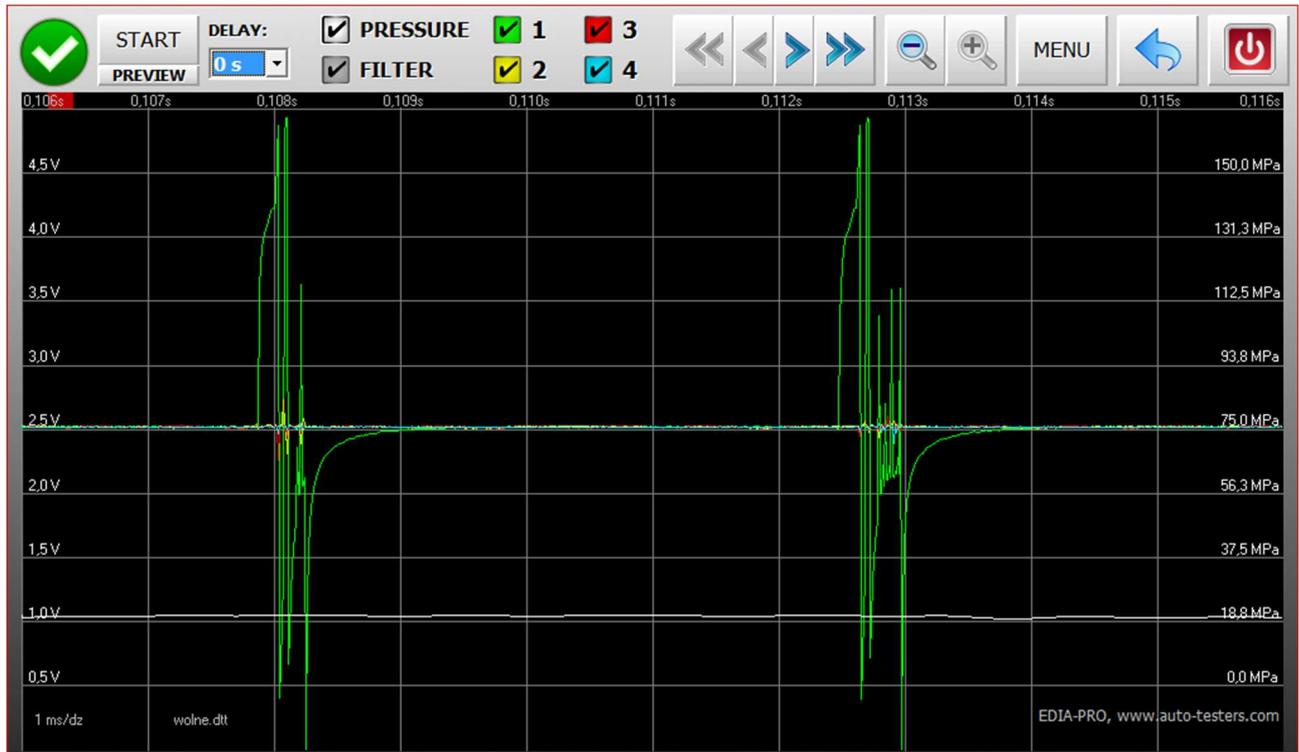
**Example: Renault Kangoo 1.5DCI (injectors DFI 1.3, DDCR driver)**

In contrast to other manufacturers, DELPHI used to supply the injector purely with the voltage of the vehicle's installation, without the use of additional voltage boost systems at the start of the opening. As a result, the initial current pulse is much broader than in other systems but with a much smaller amplitude. A coil with a resistance of typically 0.2-0.4  $\Omega$  is used to enable the appropriate power to be delivered to the injector control element.

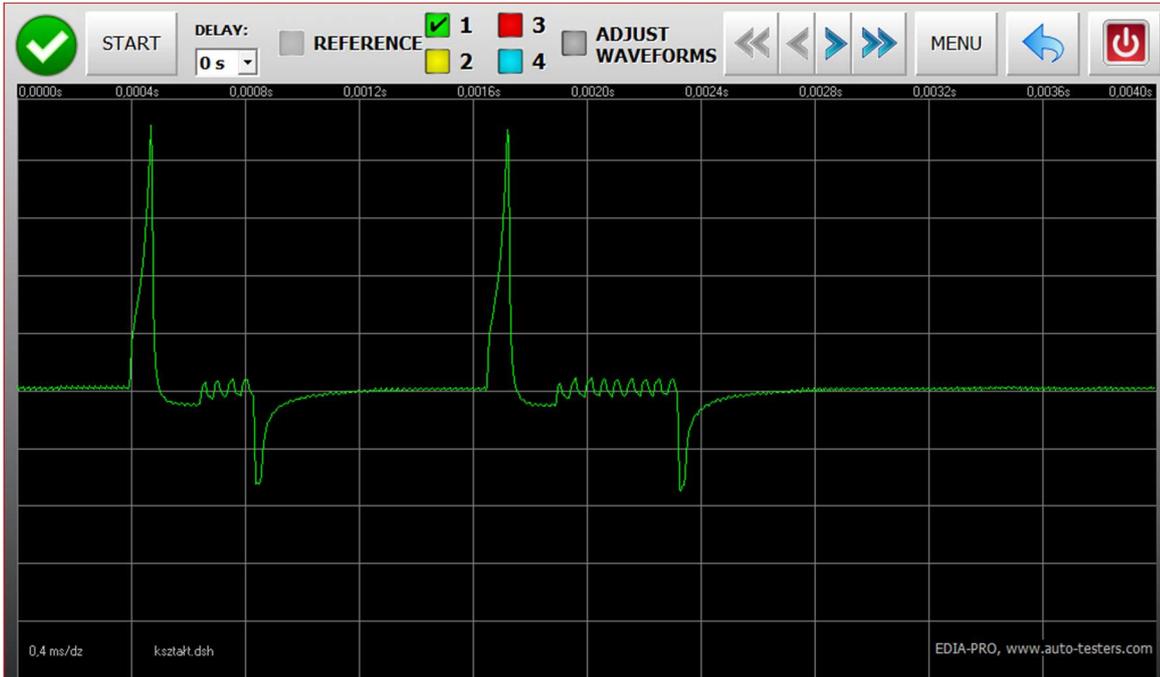
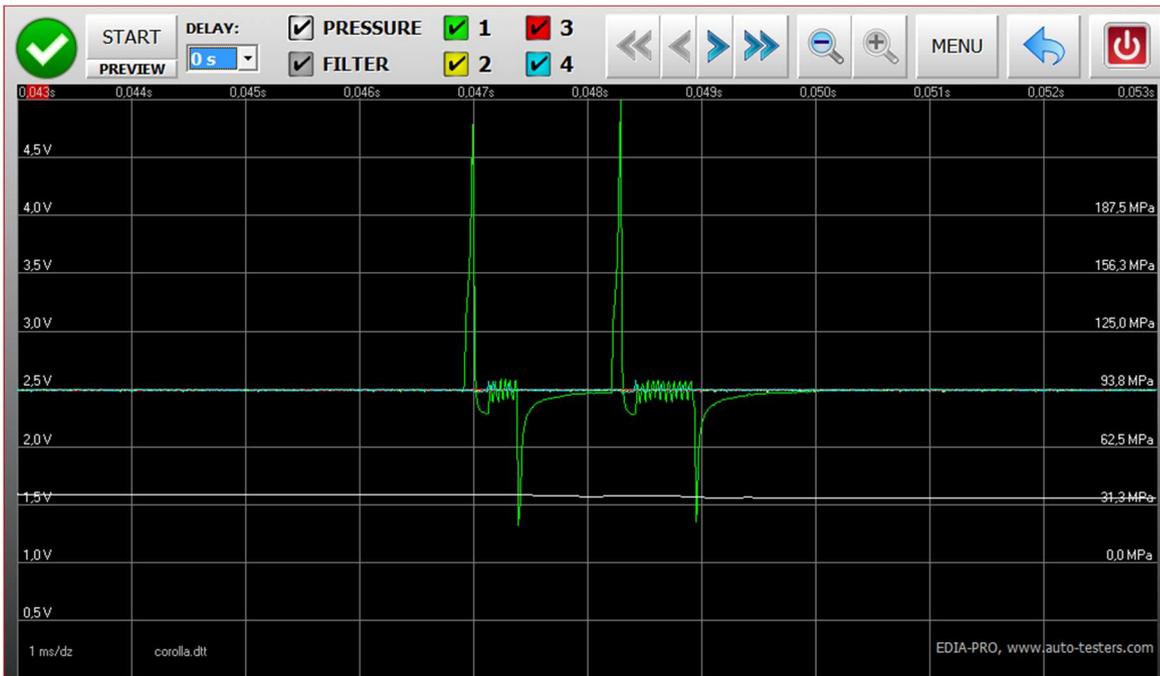
**Example: Toyota Avensis 2.0 D-4D 2005 (injector 23670-0G010)**

The first signal variant of the DENSO system shown involves injectors with a resistance of approximately 1 Ω. The control signal includes the initial high-voltage pulse and keeps the injector open by pulsing the car's system voltage.

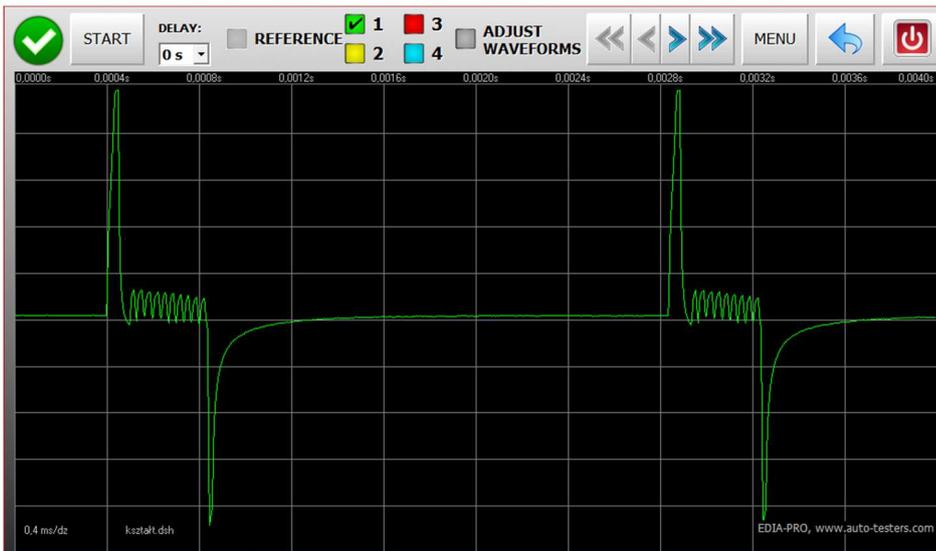
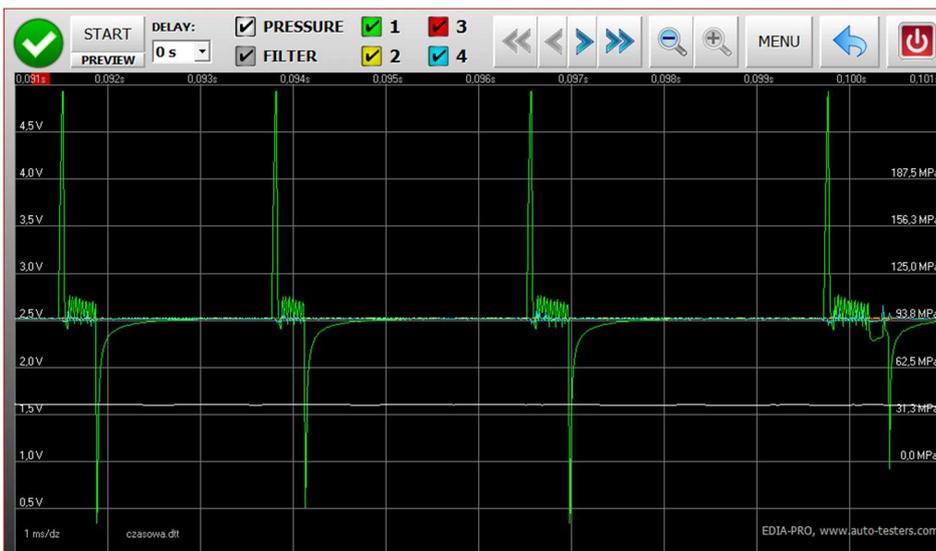
**Example: Mazda 6 2.0 CDTI 2002 (injector RF5C13H50A)**

The second variant shown differs slightly in the shape of the pulses, the electrical parameters of the injector are similar to Variant I. The timing analysis diagram shows four injection stages.

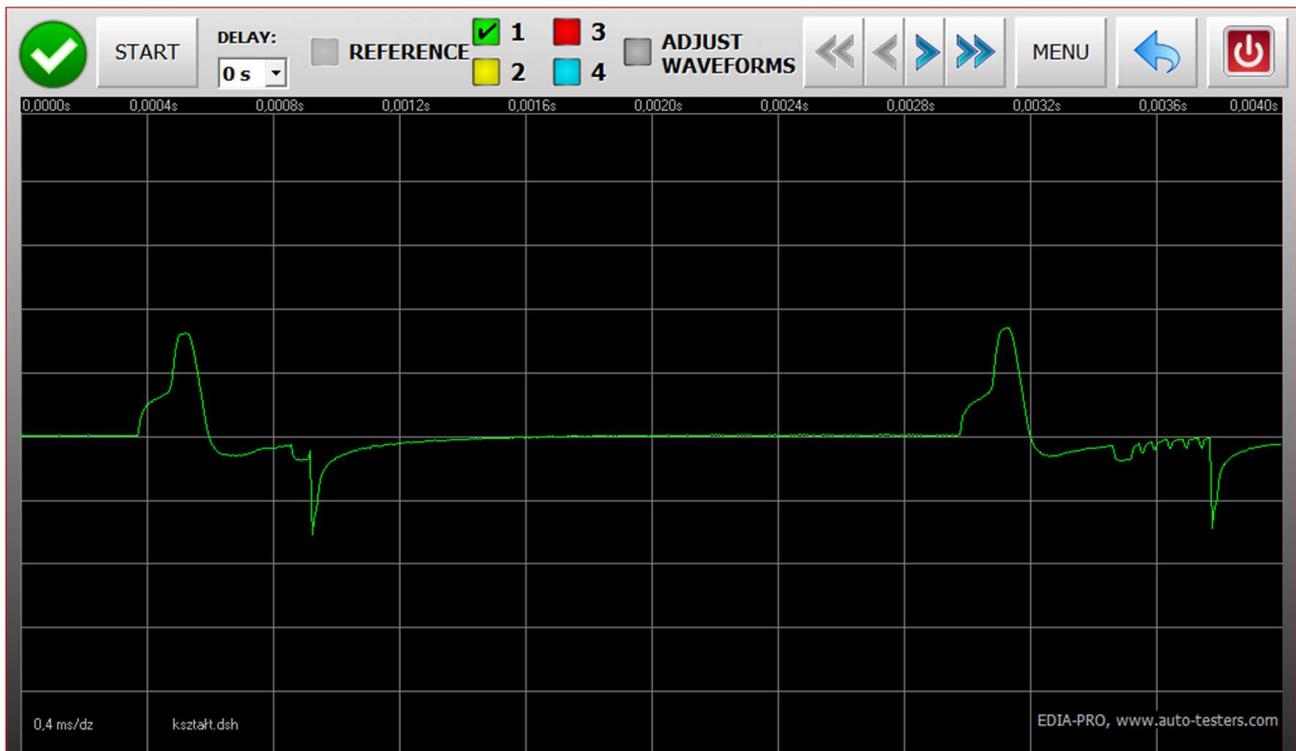
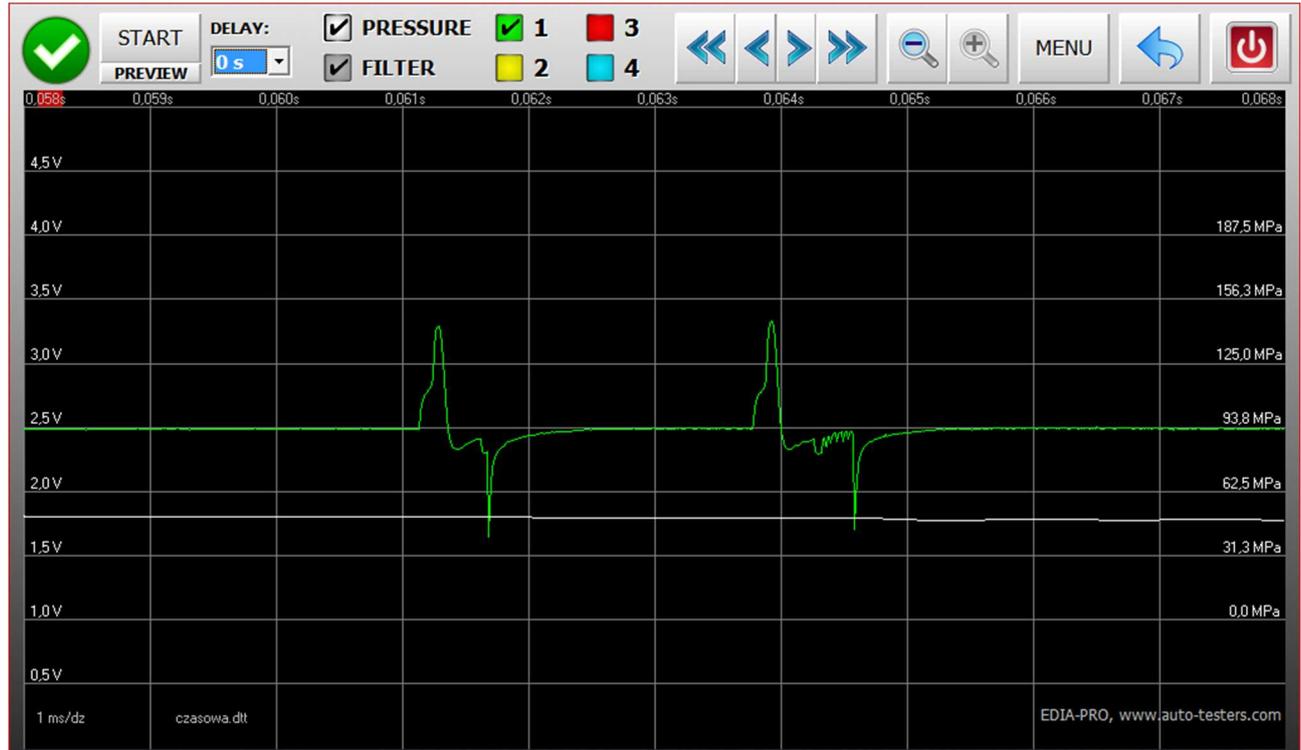
**Example: Toyota Previa 2.0 d-4d 2001 (injector 23670-27030)**

The third example of the DENSO system is significantly different from the others. In this case, the injectors have a resistance of 3.5 Ω, which clearly limits the amplitude of the signals. The supply phase of the higher voltage is necessary to provide the power required to open the injector.

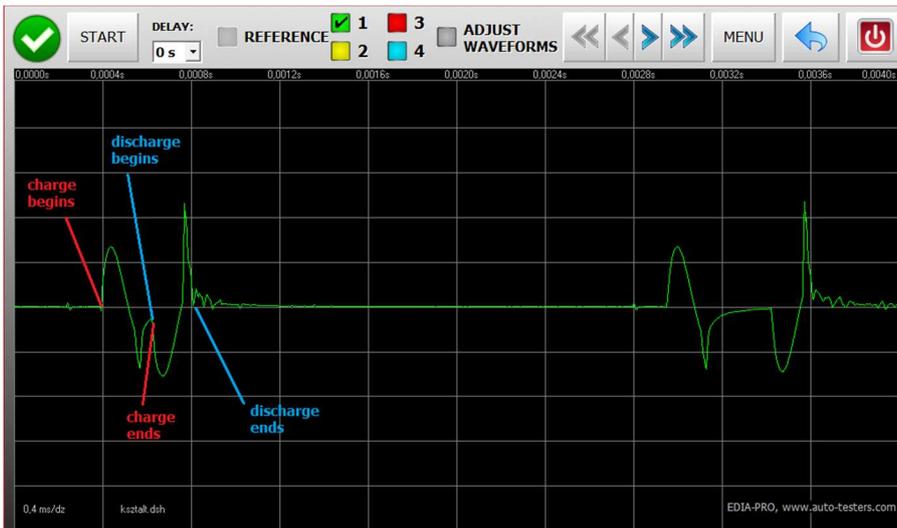
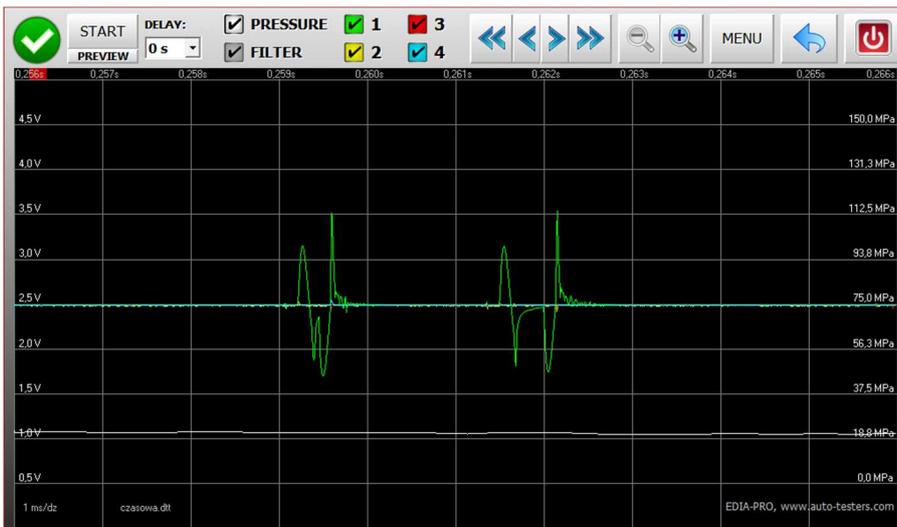
**Example: Peugeot 407 2.0 HDI (9647247280 injectors , SID803 driver)**

The first variant is characterized by particularly smooth current changes – due to the use of inductive components, the current changes slowly and the waveforms of the charging and discharging pulses are distinctly rounded. The amplitude is relatively small.

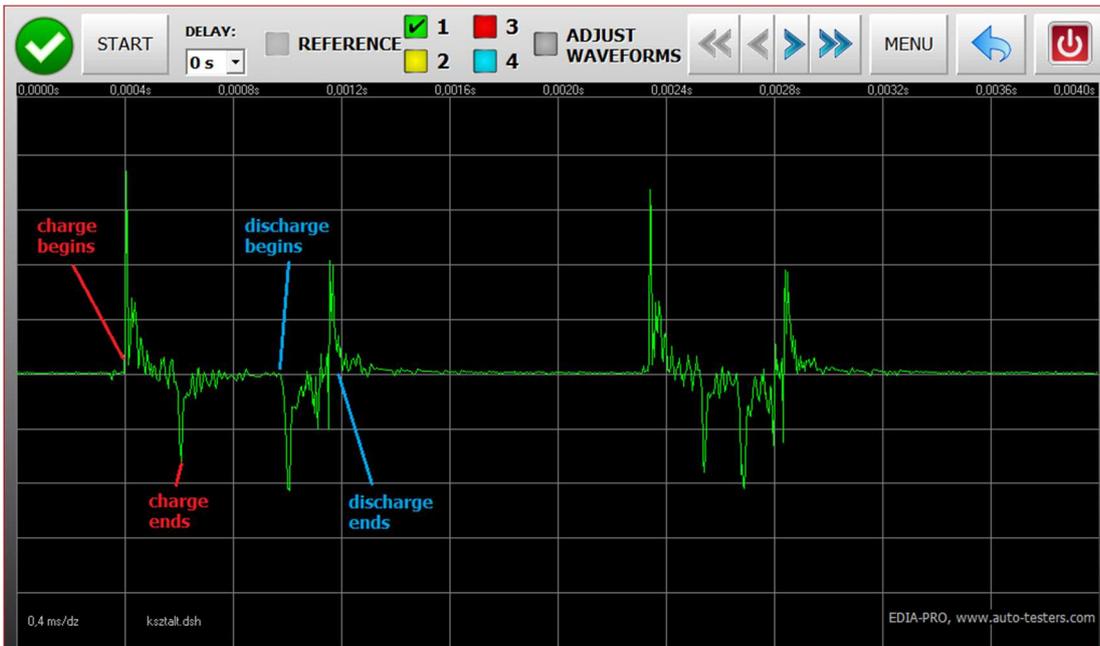
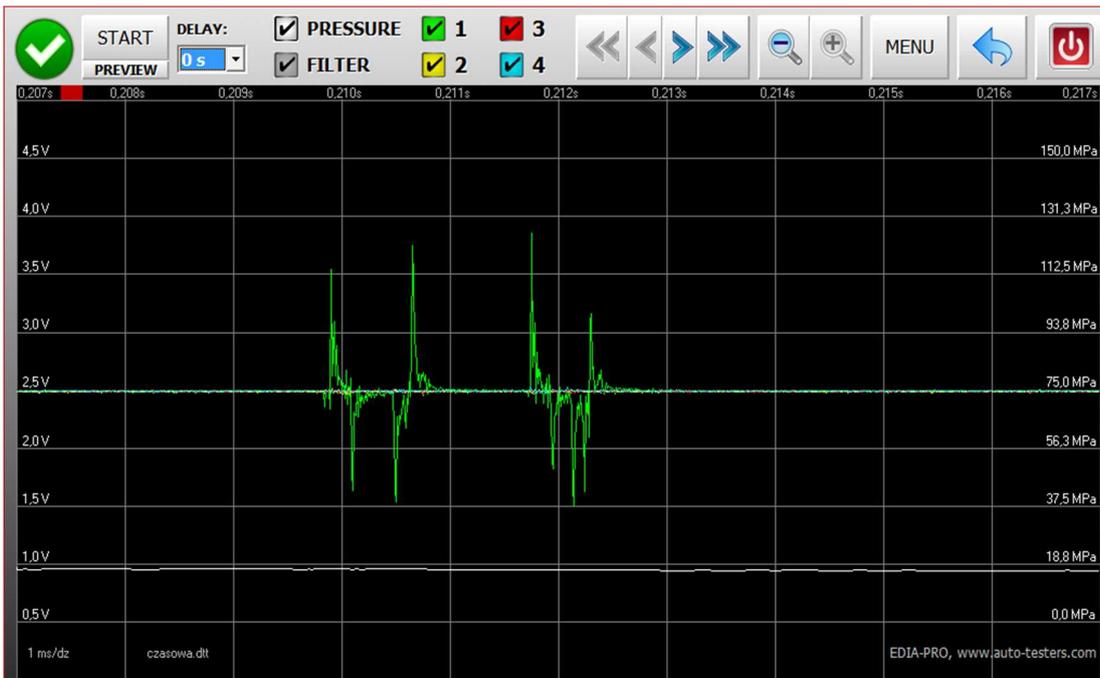
**Example: Citroen Jumper 2.2 HDI (BK2Q-9K546-AG injectors, SID208 driver)**

The second variant is characterized by more jagged waveforms, which at first glance may appear somewhat irregular. Nevertheless, the current waveforms are smoothed enough that the waveforms have a small amplitude.

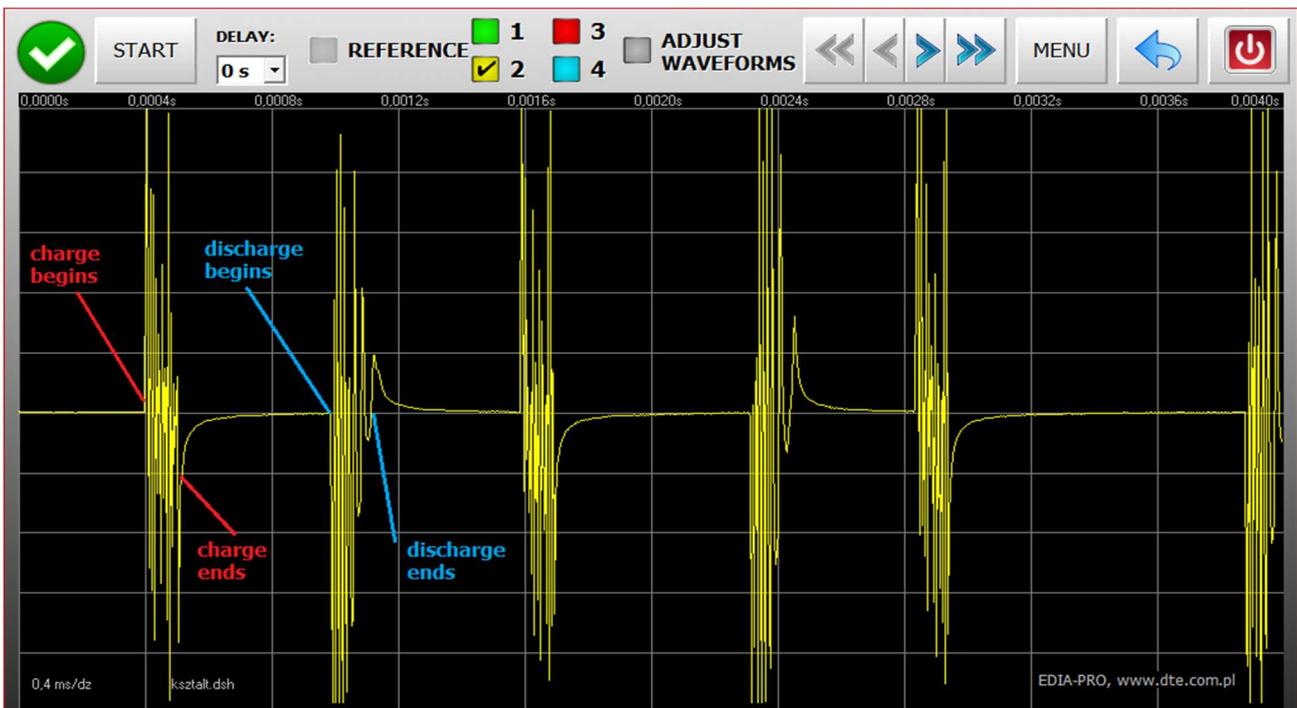
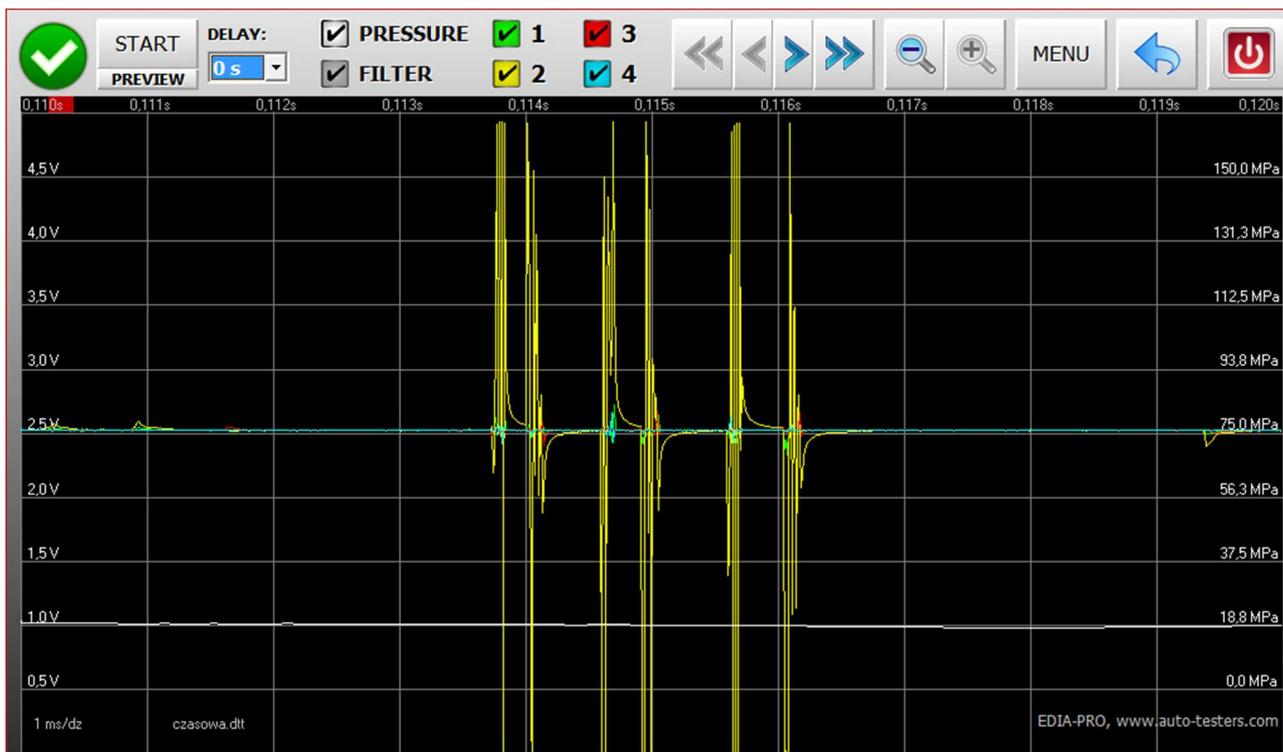
**Example: Audi Q7 3.0 TDI (0445116022 injectors, EDC17 driver)**

This manufacturer's controllers differ from the previous examples in terms of their output circuits. In this case, the regulation of the charging and discharging current of the piezo stack is done by keying at high frequency. The average current is correspondingly low (similar to that in other systems), but the output waveform is not as smooth as, for example, in the case of controllers working with Siemens injectors. Significant fluctuations in the instantaneous current value are visible on the EDIA-PRO graph as high amplitude pulses.

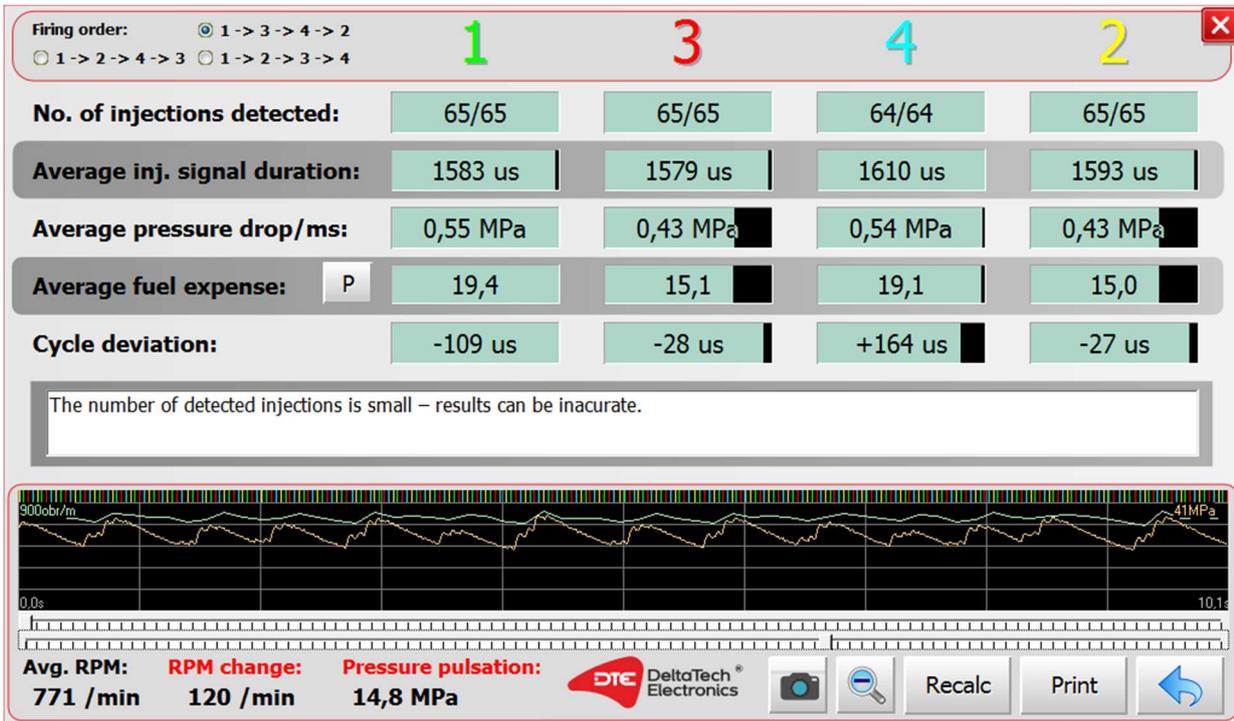
The small graph at the bottom of the window is very helpful for diagnosing the pressure control valve. In this case, it can be seen that along with the observed engine speed fluctuations, there is a noticeable oscillation

in the pressure value. The period of these fluctuations is about 0.7 seconds, and this type of pressure fluctuation, significantly slower than the engine and pump is a typical symptom of a sticking control valve.

At the same time, the measurement table shows some uneven engine operation (cycle time deviation). However, at this stage, we refrain from assessing the injectors, as the observed phenomena clearly disrupt the operation of the entire system. Additionally, the measurement was taken with a cold engine. In order to reliably assess the injectors performance, the main fault must first be resolved.

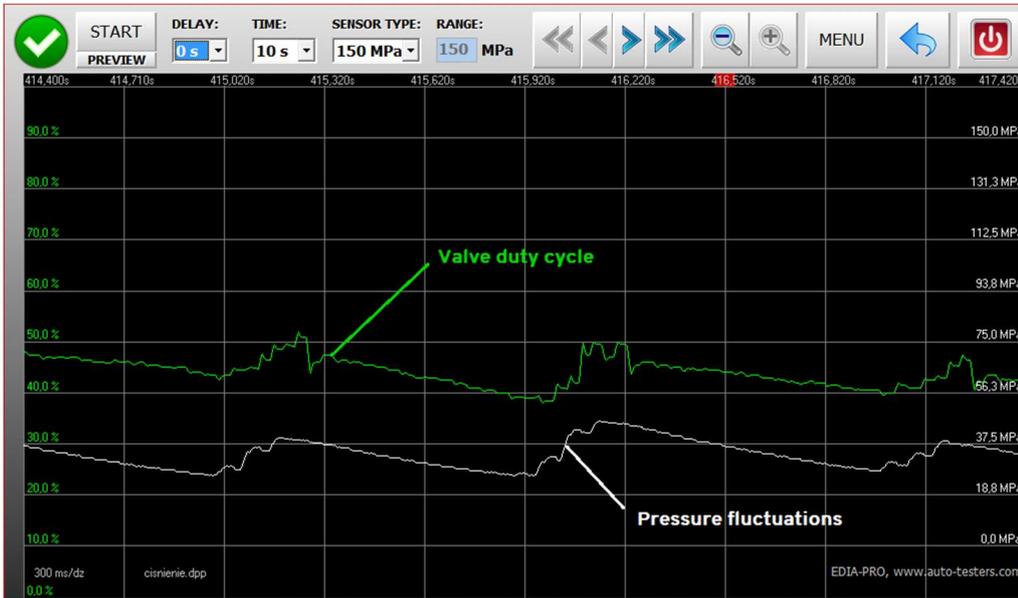
The measurement showed that the pressure fluctuations were also accompanied by fluctuations in the control value of the control value – in the graph, in addition to the pressure (white), the duty cycle of the valve control signal (green) is also visible. In this case, the control valve clearly qualifies for replacement.

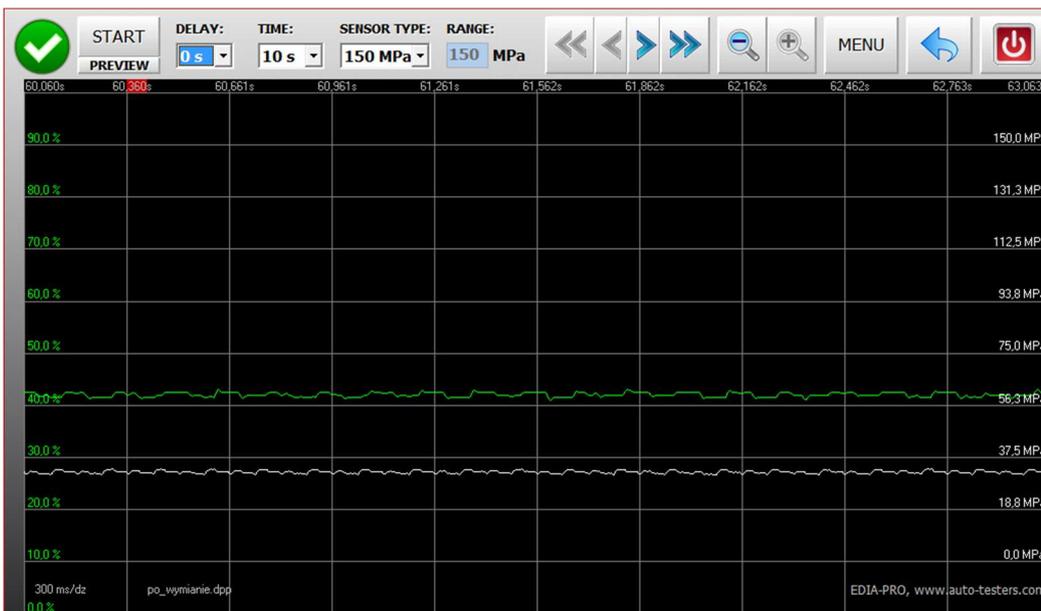
As can be seen in the graph above, the pressure fluctuations have stopped, and the control valve signal is stable.

Minor fluctuations indicate that the regulation system is functioning correctly.

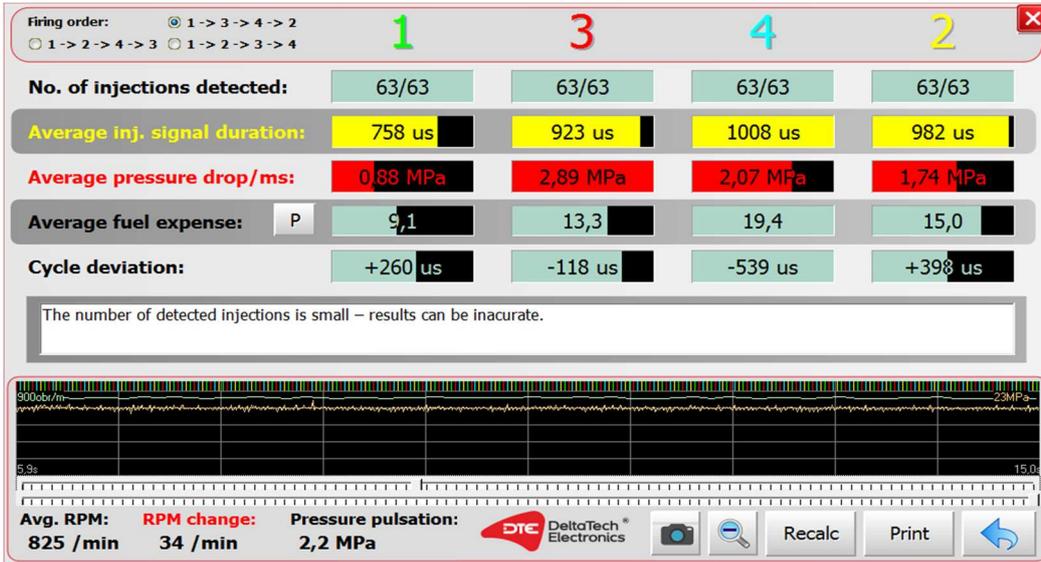
At first glance, there is a significant irregularity in the timing of the signals controlling the injectors.

At the same time, there are significant differences in engine running consistency. The operation of cylinders 1 and 2 is clearly weaker (positive parameter „cycle time deviation”).

The tests performed so far seemingly indicate a possible problem with the injectors. However, a close look at the parameters reveals a certain problem. The previously shown differences in injector control signals do not correspond to the observed cycle time deviations (engine speed fluctuations).

For example, cylinder no. 1 has a longer cycle time, meaning the engine slows down. The work of this cylinder is lower than average. At the same time, the injection signal duration is the shortest of all. Therefore, the computer, by applying such control, led to this state. The natural reaction to such a case would be to increase the dose, and therefore the duration of the control signals.

Why didn't that happen? Because although the injectors were replaced with new ones, they were not properly coded. As a result, the controller retains the data and adaptations for the previous injectors, and the new components are being controlled as if they were worn.

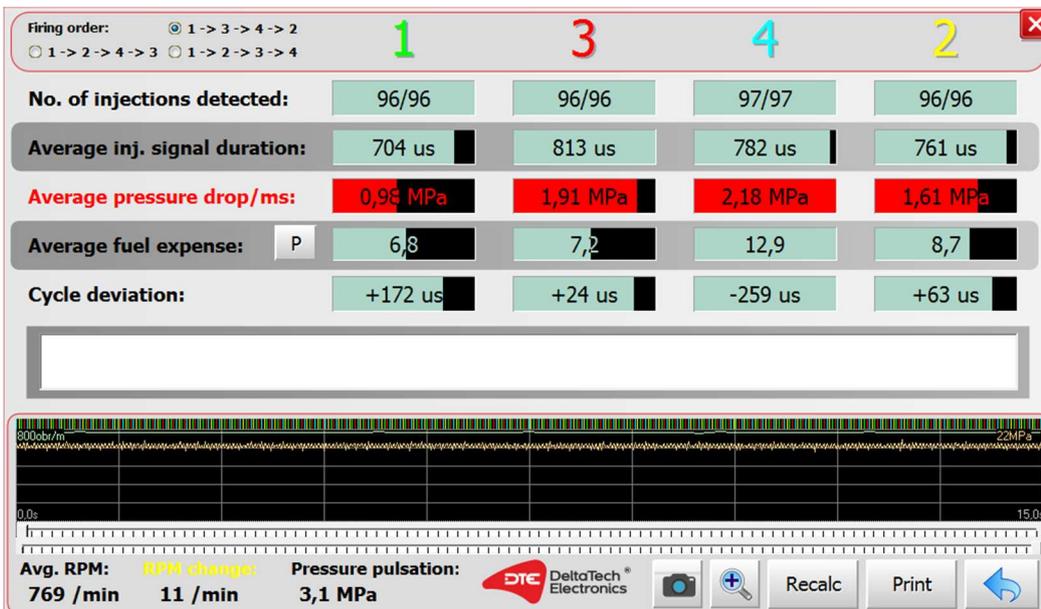
As can be seen, even after the engine warms up, its operation remains incorrect, despite the apparent improvement observed.

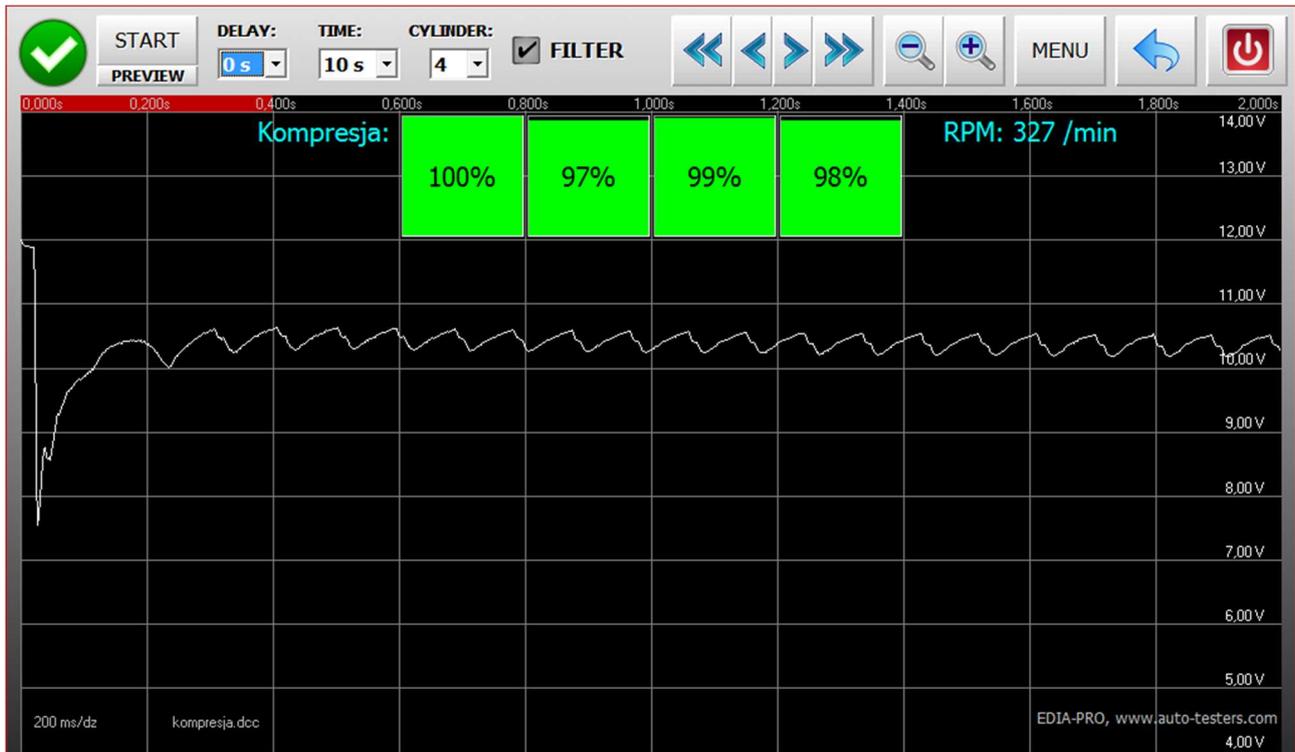
The measurement showed that the compression differences between individual cylinders were minimal, so they would not affect the engine running consistency.

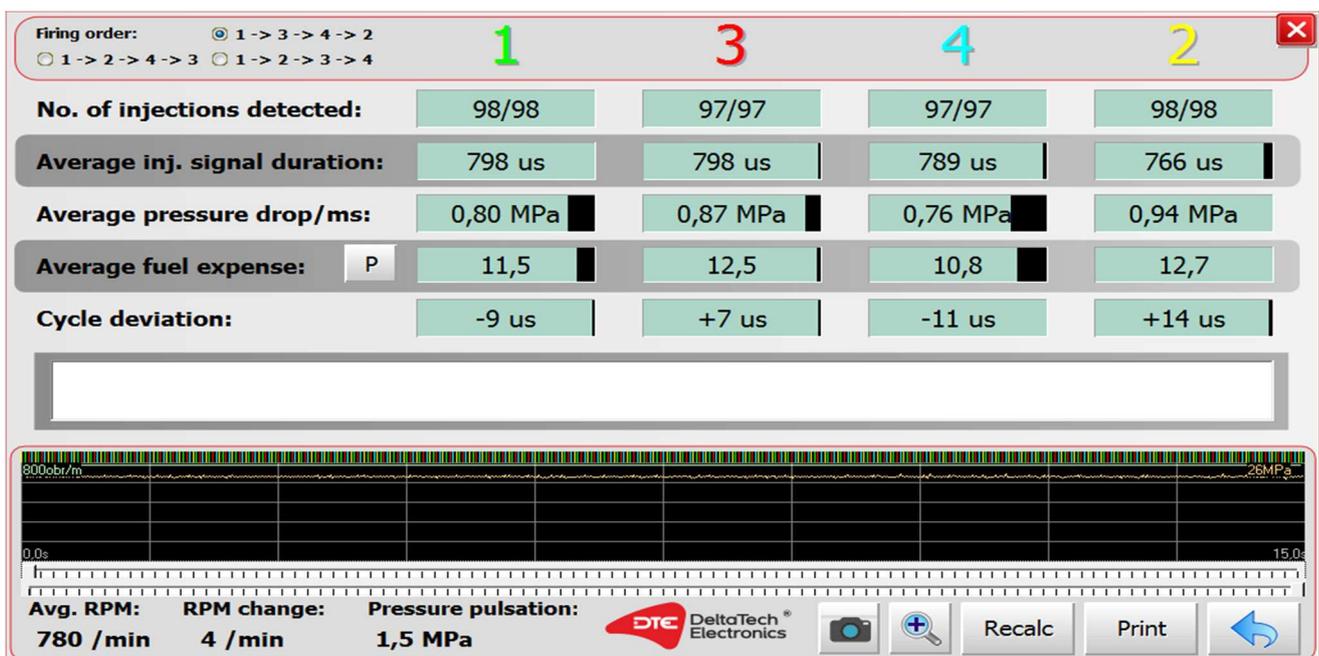
The idle speed is almost perfect, the measured parameter deviations are small. The pressure and RPM values are very stable.

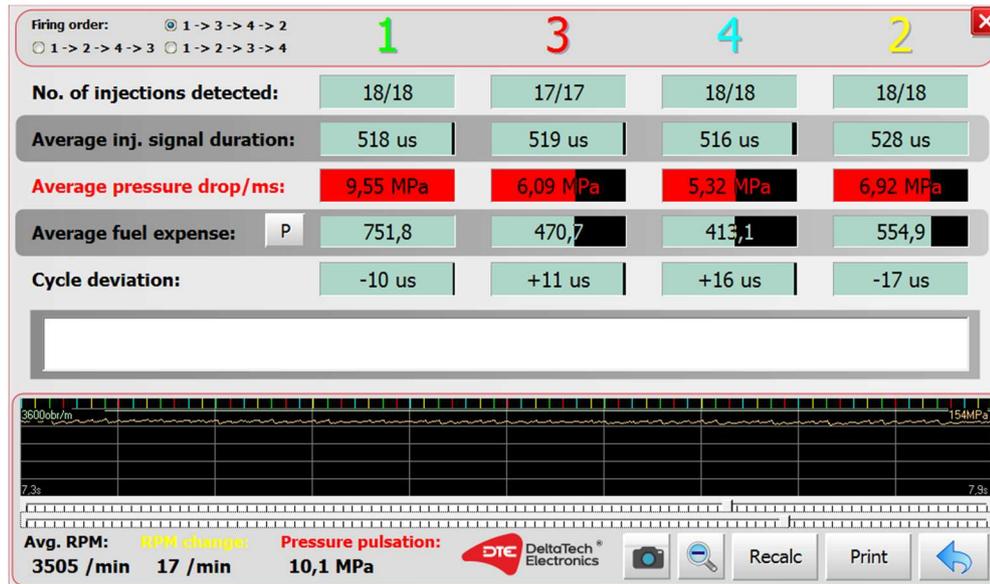
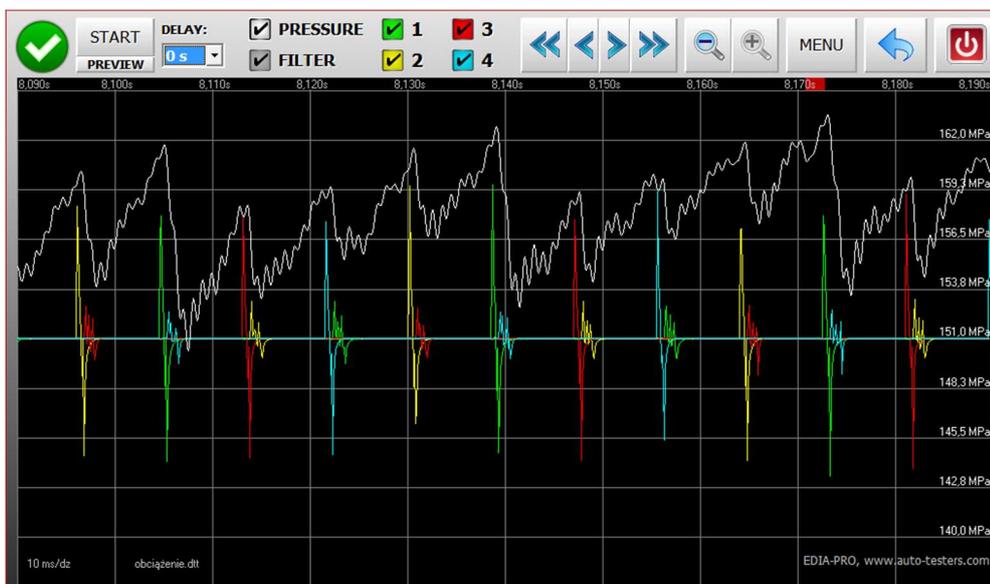
The results of the automatic analysis show that at approx. 3500 RPM and a pressure of approximately 150MPa, the fuel consumption of injector 1 increases significantly. This is also very clearly visible on the waveform:

After replacing injector no. 1, the problems disappeared. A control measurement was performed under similar operating conditions:

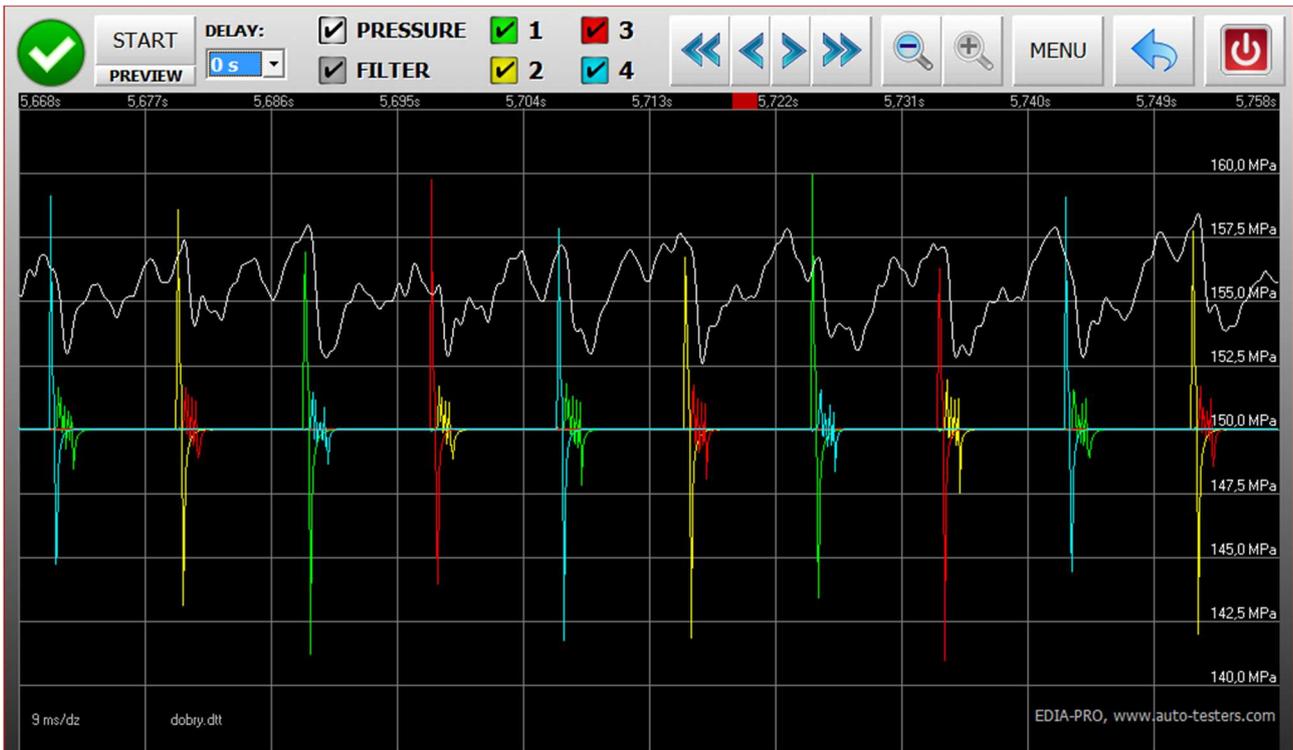
In this case, the pressure drops are much more balanced - this is the correct operation of the system.

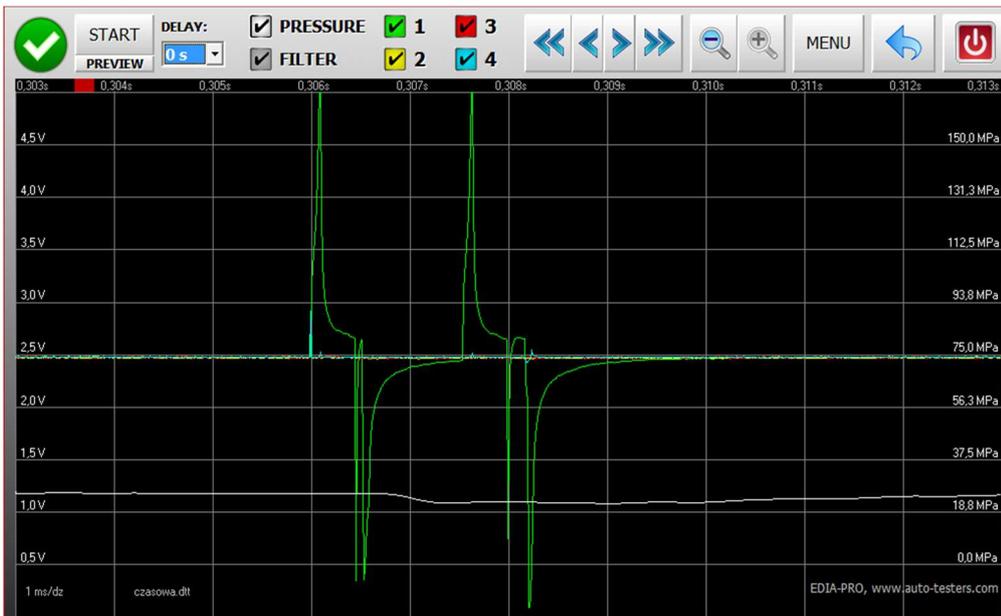
An experienced user would immediately notice an unusual waveform shape in this case (Bosch electromagnetic injector). Next, a measurement was performed at idle speed in the „waveform analysis” mode, which allows for a more detailed examination of waveform shape.
