## EDIA-PRO: PRACTICAL TIPS

### 1. Injection signal form – electromagnetic injectors

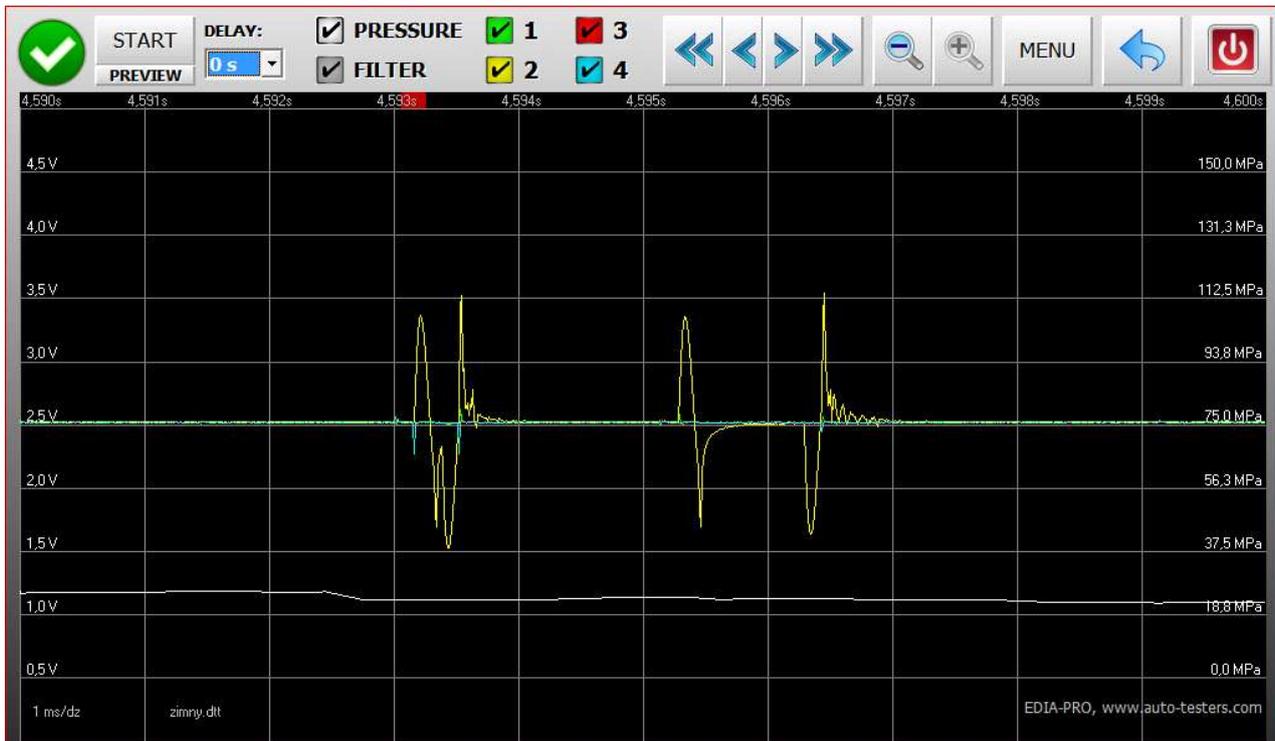
The waveform and pressure values are typical for the system used with piezo injectors.

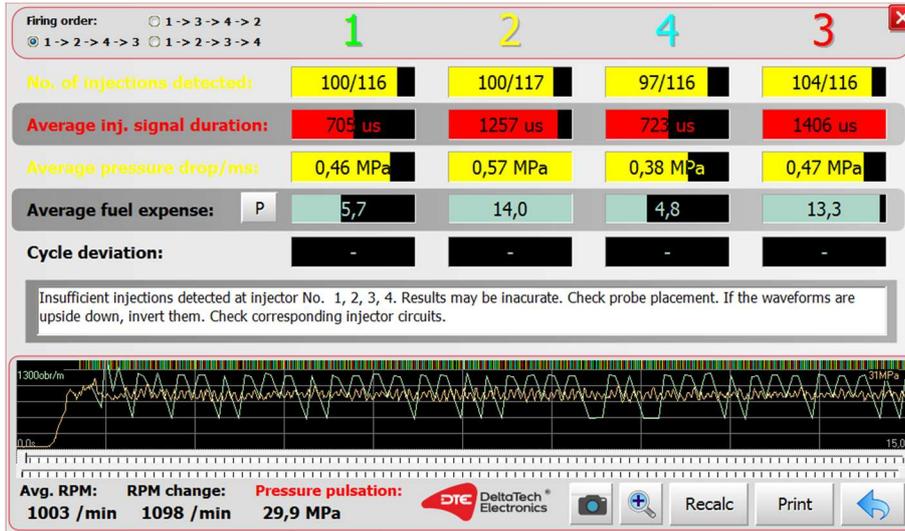
The results obtained are very unusual.

The first row of the table (number of injections detected) may suggest that the signal of the injectors was not detected correctly and the rest of the parameters should be expected to be unreliable.

The lower graph shows a very large jaggedness of the RPM graph – such changes are not physically possible, they are the result of an incorrect interpretation of next injections.

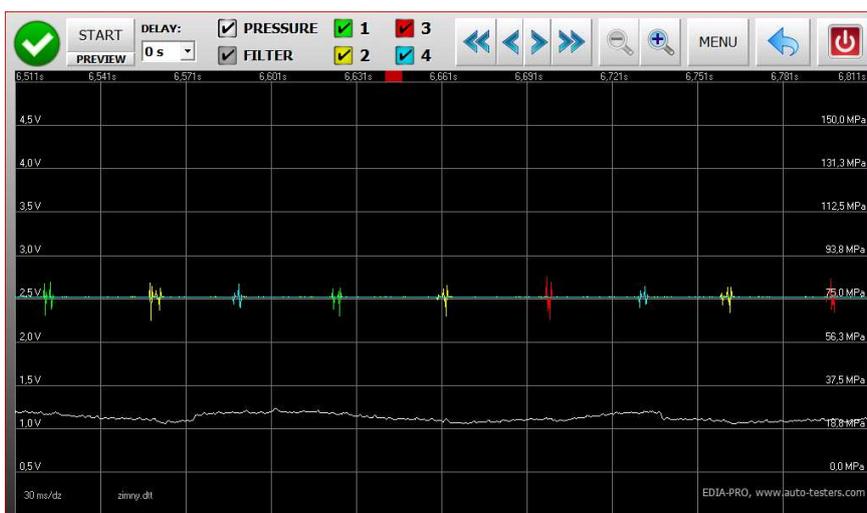
The apparent order of the injectors is: 1-2-4-1-2-3-4-2-3. This sequence cannot be correct, even if the measuring probes are incorrectly positioned. The engine is running incorrectly, and the fuel is not delivered to the correct cylinder in each cycle. This is what made the automatic analysis mode used previously no longer useful. A correct injection sequence is a prerequisite for accurate measurement of the RPM and other parameters.

In this situation, suspicion falls immediately on the camshaft position sensor. After verifying the wiring, the sensor was replaced, which resolved the issue.

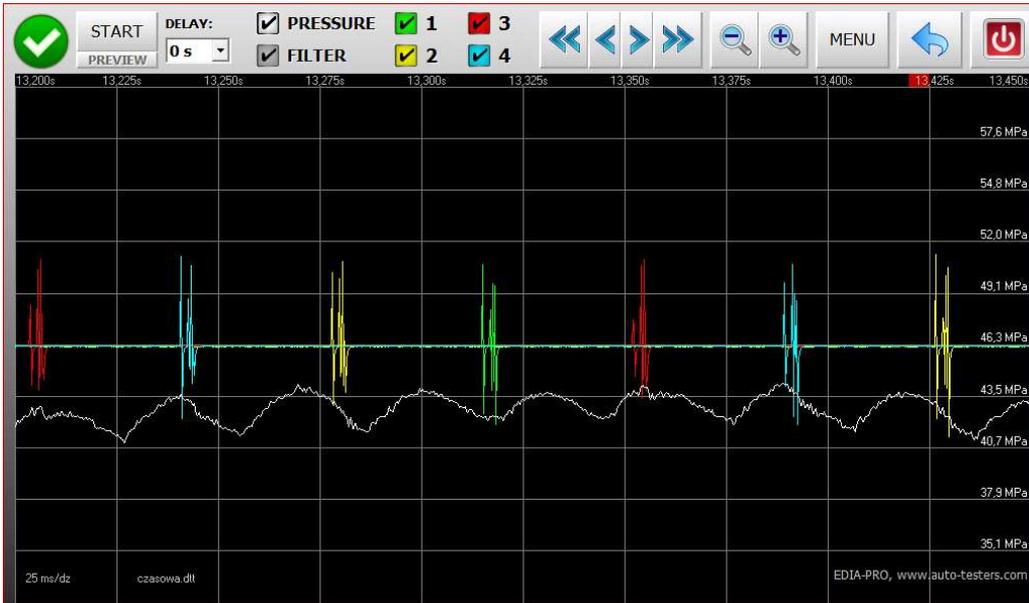
The injector signal shape appeared completely normal, showing four injection phases during idle:

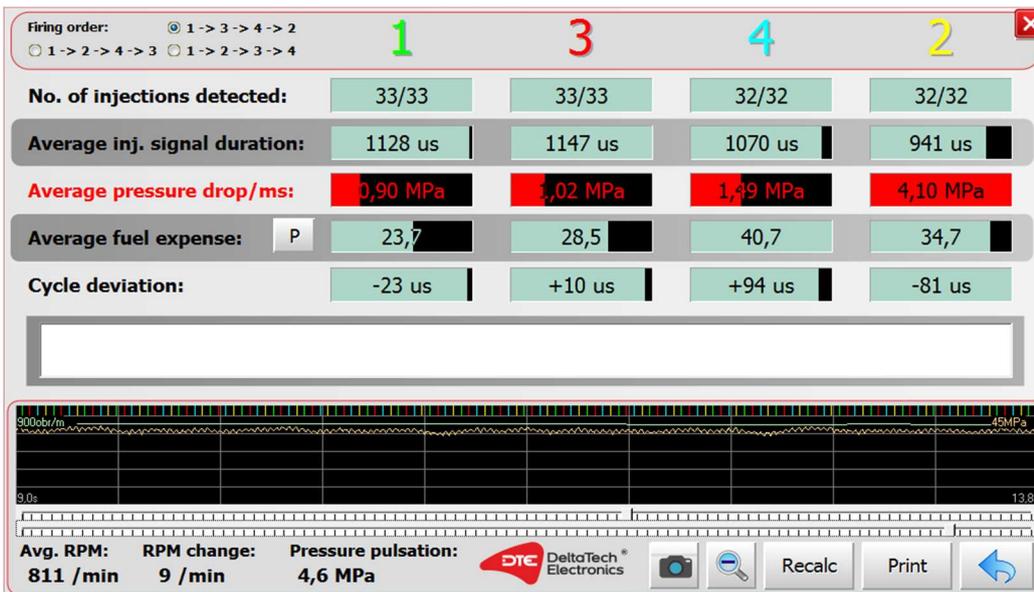
Concerns were raised by a significant scatter in the automatically determined fuel delivery and the „average drop/ms” parameter.

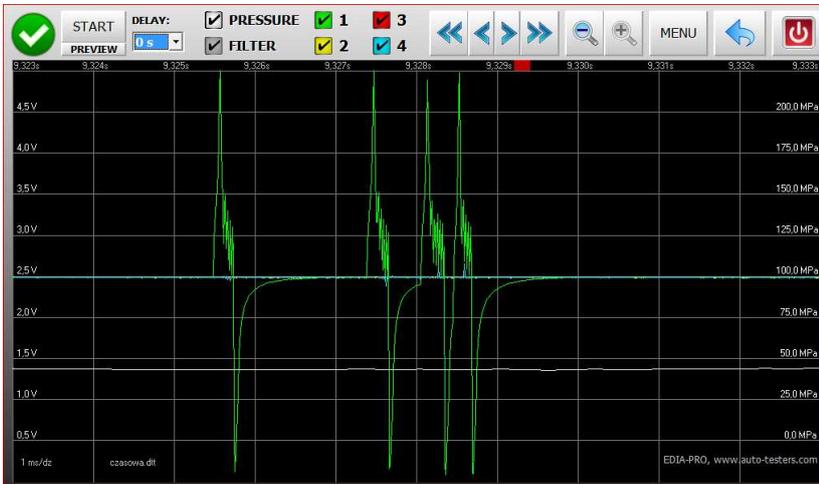
The waveform proves that the way the system works, specifically the pressure fluctuations associated with pump operation adversely overlap with the drops associated with injection, which falsifies the automatic measurement (under idling conditions, the pressure fluctuations are greater than the drops associated with injection and occur simultaneously).

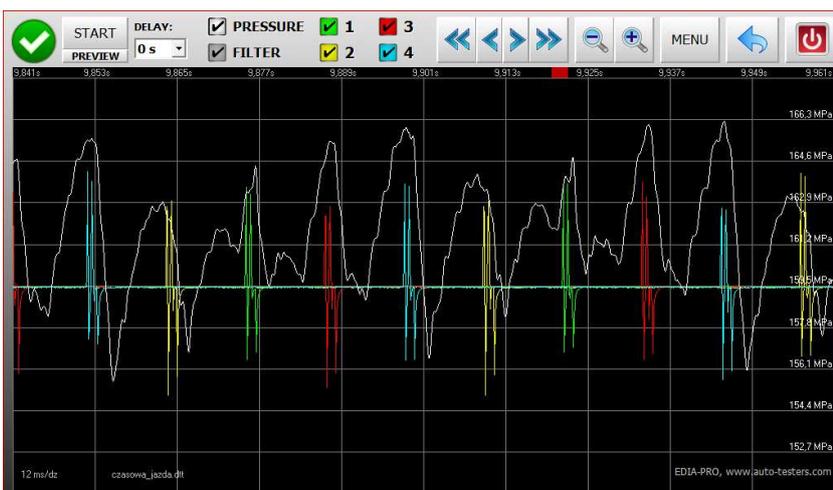
It became evident that under increased load, there is a significant irregularity in the pressure drops associated with injection. At the same time, the measurement in automatic analysis mode for this section also gives

an increased cycle time deviation for the 4th cylinder of +37 us. This value would be good at idle, but for an engine at 3,000 rpm it is quite high.

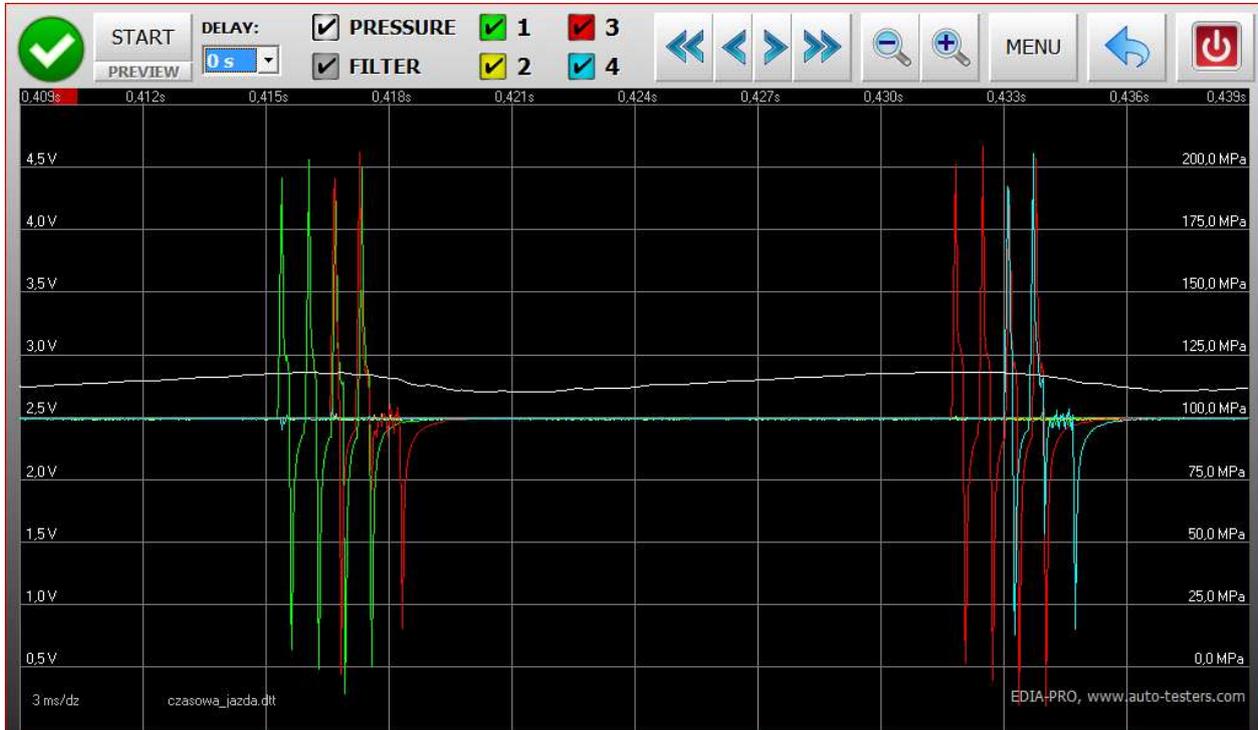
Here we see two consecutive injections – on injector 3 (red), and 4 (blue). Simultaneously with the injection on injector 3, fuel is injected into cylinder 1 (green), and the next injection is accompanied by the injection of fuel additionally into cylinder 3. The waveform shown illustrates the DPF regeneration process. The first injection in cylinder 3 (two injection stages) initiates the work stroke, the next injection (four stages) occurs at the start of the exhaust stroke – the fuel goes to the exhaust and the filter where it raises the temperature, leading to the combustion of soot particles.

Based on the measurements taken, the 4th injector was identified as suspicious. After replacing it, the system problems disappeared. In this case, the malfunction of the injection system was the cause of excessive soot production, which led to the rapid filling of the diesel particulate filter. The cleaning procedure, which was triggered regularly, generated significant amounts of light-colored smoke. The presence of the DPF masks one of the symptoms, which is black smoke – soot is accumulated in the filter. If the injector fault is not diagnosed in time, this will lead to premature wear of the diesel particulate filter, which will significantly increase the cost of the repair.
